Electronics Online Challenge Entry

Date: 01/9/2018 Team: 6403A Team Name: A for effort School: Brookside

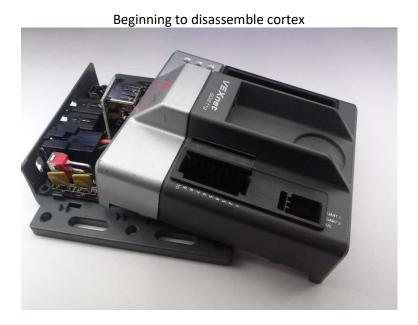
Cortex with cover off.
