UE Wonderboom Electronics Analysis

Texas Instruments Electronics Online Challenge

YNOT Robotics

University of Tennessee, Knoxville

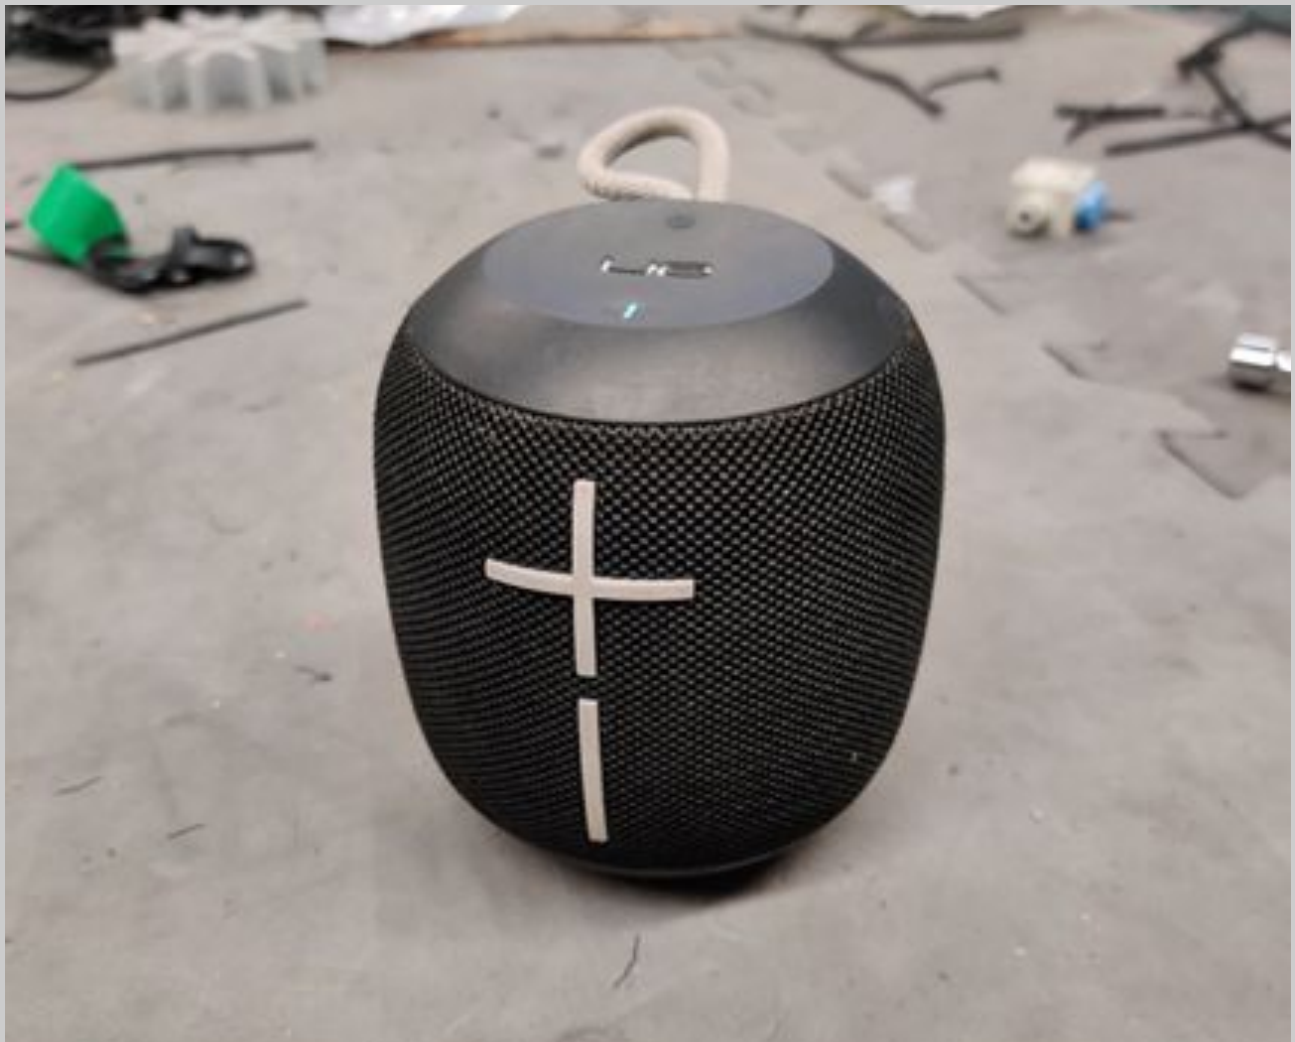
Figure 1: Team YNOT's UE Wonderboom speaker before being dismantled for this challenge.

For this year's Texas Instrument Electronics Online Challenge, our team chose to dismantle and analyse a UE Wonderboom speaker (**Figure 1**) which has been intensively used by our team for several years. This speaker was of particular interest because it no longer retains charge. Through this project, we hoped to deduce the cause of the speaker's electronic issues (i.e. battery, blown or bent USB port, or water damage) and make the necessary fixes if possible.

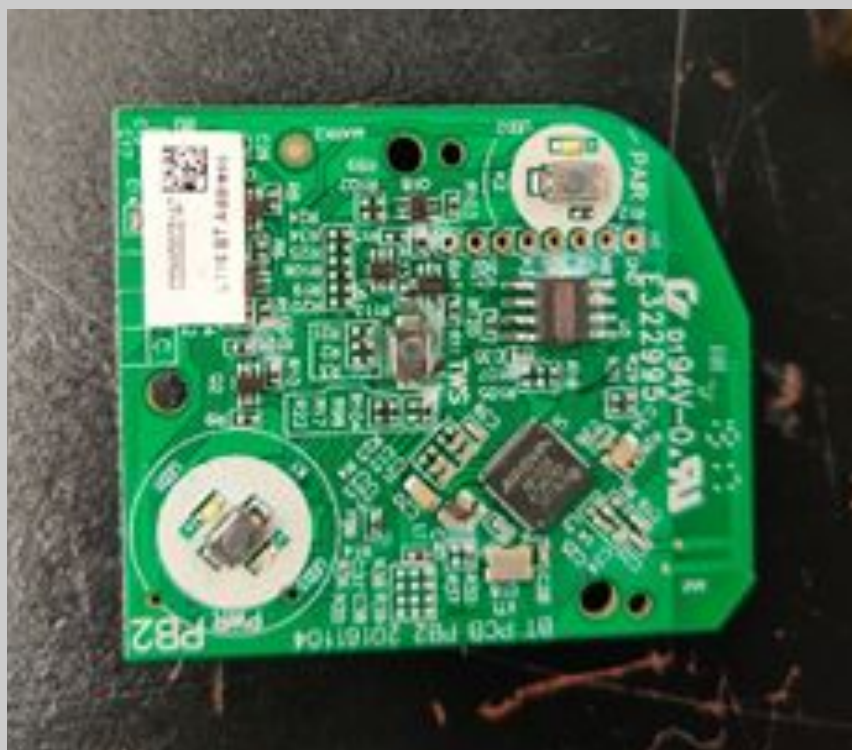
Figure 2: The Bluetooth and UI Board

Inside the speaker, we found a total of five different boards including two main control boards stacked in a mezzanine configuration (**Figure 2 and 3**), a volume button board (**Figure 4**), a battery module board (**Figure 5**), and a USB port board (**Figure 6**). Additionally, there were two speaker drivers with a resistance value of 4 Ohms (as measured by a multimeter), two passive bass radiators, and a 7.98 Wh single cell battery. Upon first glance, one main board seems as if it is primarily used for Bluetooth connectivity and user interaction (such as the power button), and the other seems like it is primarily used to drive the speaker with a section that could be a battery management system (BMS). All the major chips are Texas Instruments products. The three smaller boards are very simple and only have resistors, capacitors, transistors and connectors.

Bluetooth and UI Board (Figure 2)	Audio and BMS Board (Figure 3)
1x AIOHA AB1520	1x Texas Instruments TPA3130
1x Fudan Micro FM25Q08A	1x Texas Instruments BQ24250
1x Six Pin Female Mezzanine Connector	1x Texas Instruments TPS61088
1x Fourteen Pin Mezzanine Connector	6x Inductors
3x LEDs	6x Electrolytic Capacitors
3x Push Buttons	1x Six Pin Female Crimp Connector
	1x Five Pin Female Crimp Connector
	1x Four Pin Female Crimp Connector
	1x Three Pin Female Crimp Connector
	1x Fourteen Pin Male Mezzanine Connector
	1x Six Pin Male Mezzanine Connector

On the Bluetooth and UI Board, we found that the Airoha AB1520 is a Bluetooth 4.2 receiver and decoder which is used to transfer audio from your personal device, such as a phone or laptop, and turn it into an amplifier-ready format. The Bluetooth and UI Board also contains the Fudan Micro FM25Q08A, which is a memory chip used to store Bluetooth pairing information. On the Audio and BMS Board, we found a TI BQ24250, which is a single cell battery charging chip for battery management, and the TI TPS61088, which is a boost converter chip that provides a higher voltage for the audio amplifier input. The most important component on the array is the TI TPA3130, which is the primary audio amplification chip and provides 50Wx2 at 4 Ohms.

In terms of diagnosing the issues with the UE Wonderboom speaker, we found that many of the components on each board were corroded, most likely due to water damage. This corrosion likely caused poor contact on the charging chip and its auxiliary components, which can be easily fixed by cleaning the corroded parts.
