VIQC MIDDLE SCHOOL –
REVERSE ENGINEERING
CHALLENGE

Dell Inspiron 13 5000 Series 2 in 1 Laptop

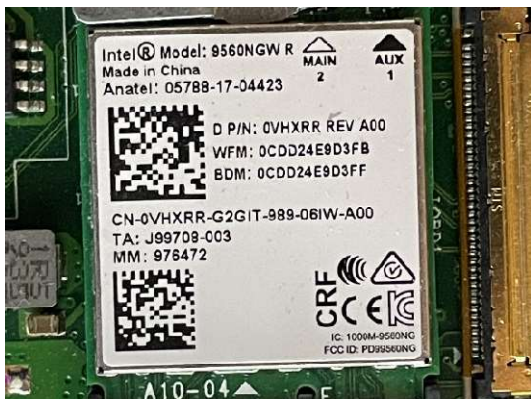
The first, and biggest component I chose to research was this INTEL 9560NGW R. It is not very prominent on the internet, but I managed to find one reddit thread about the device, in which people were

replace this hybrid Bluetooth/Wi-Fi card. It is a Wave2 80MHz Bluetooth 5.1 PCIe based card, and interestingly takes up only 50% of the assigned motherboard space as it was designed to fit the socket of its predecessor the 9560NGW that was designed for miniature laptops in the late 2010's. It was eye catching, as it had no clear route to the cooling, and was mounted extremely close to the battery. This told

me that it must not be a heat-dependent component as I know from experience that the battery gets very hot under heavy loads.

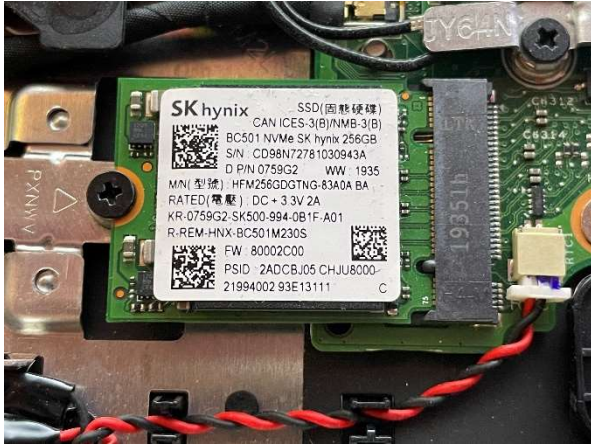
The second component I investigated was this SK Hynix 256GB SSD. This was used almost solely as a boot drive, as our files were stored on OneDrive. This component was small, and caught my eye, I have worked on SSDs before, but this one was different, it was half the size and is mounted on a bracket in the middle of the NVMe slot. It had very little external damage, except for the fact that a few of the solder points connecting the NVMe slot to the motherboard had come loose, allowing the SSD to shift around in the mount quite a lot.
