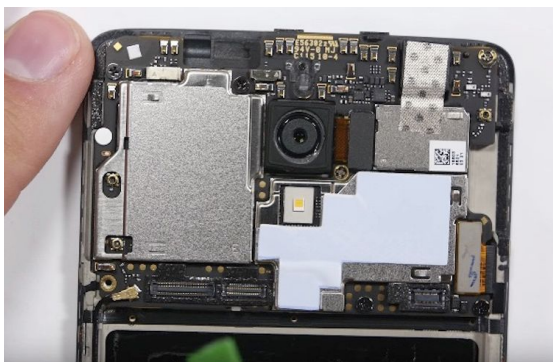
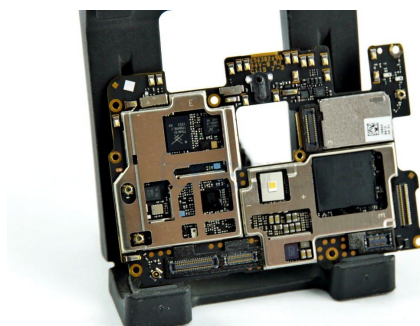
Upon opening the Oneplus 3, immediately the team saw the exceptional build quality that Oneplus had for their product. After removing 2 screws at the bottom of the phone, the back of the phone; a solid slab of aluminum; popped off with ease allowing to view the internals of the phone such as the battery, charging PCB and the motherboard.

The structural integrity of the phone is held using a battery which was a very interesting design choice by OnePlus. Rather than reinforcing the sides of the middle of the back, the design team used the battery that was rated at 3000 mAh, using a classic black color, rather than the red colors previously used in the OnePlus One and Two. The battery pushes against the side of the chassis removing any need for adding an aluminum support in the area, lowering weight, while also making the phone very robust.

On the same motherboard, the system chip was found which is a Qualcomm Snapdragon 820 which, at the time, was the best in the market for the phones in the generation. On top of that, on the motherboard you can find both the GPU and the 6 gigabytes of RAM. The RAM is rated at a very high speed and is rated at LPDDR4.
